ERDC/GSL TR-17-13

Geotechnical Evaluation of the Brownsville Levee Cracking and Partial Slope Failure

June 2017

Final report

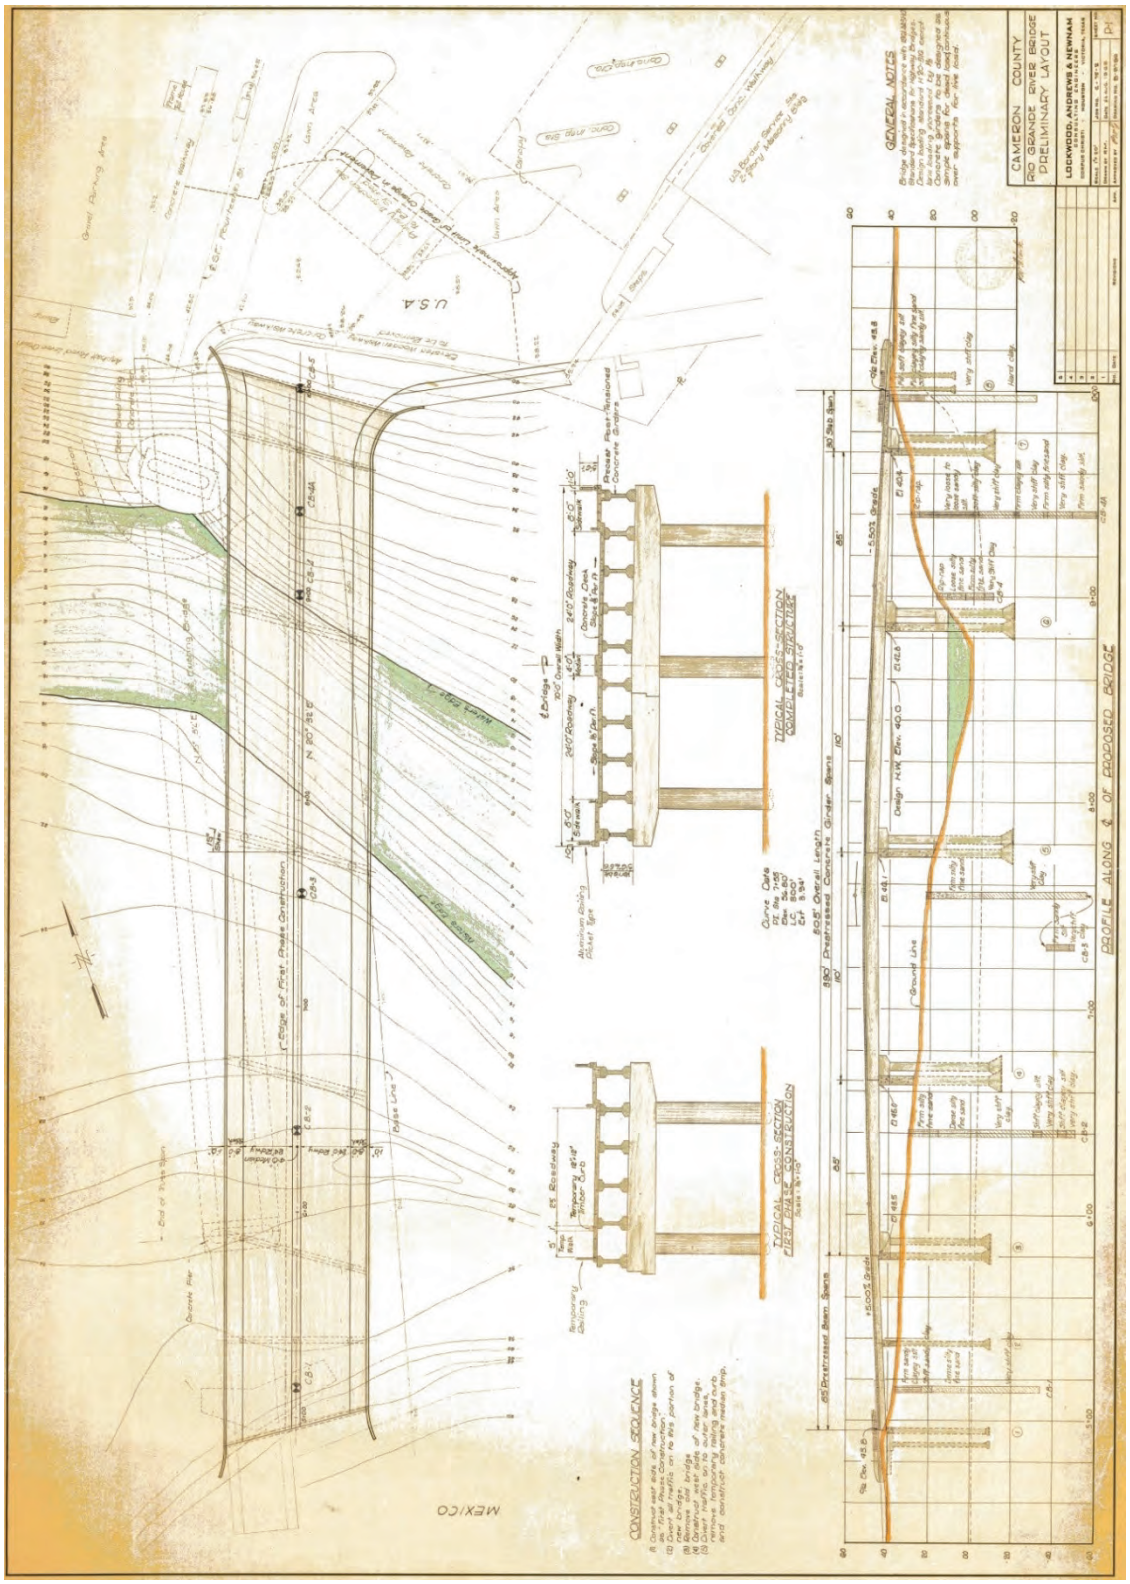
The current bridge began experiencing settlement issues in 1984 at Pier No. 5, with distress visible in the concrete deck span. Subsequently, a geotechnical study was commissioned by the Cameron County Engineering Division to evaluate the soil conditions responsible for settlement (Professional Service Industries 1984). Included with this evaluation were geotechnical borings and results of laboratory soils testing. The remediation of the bridge pier involved the construction of deeper support piers and a support frame to the original pier (Figure 2.4). Soil layers responsible for the pier settlement are similar to those present in the area experiencing cracking.

Figure 2.3. Gateway International Bridge details and borings (Lockwood, Andrews, and Newnam 1962c).

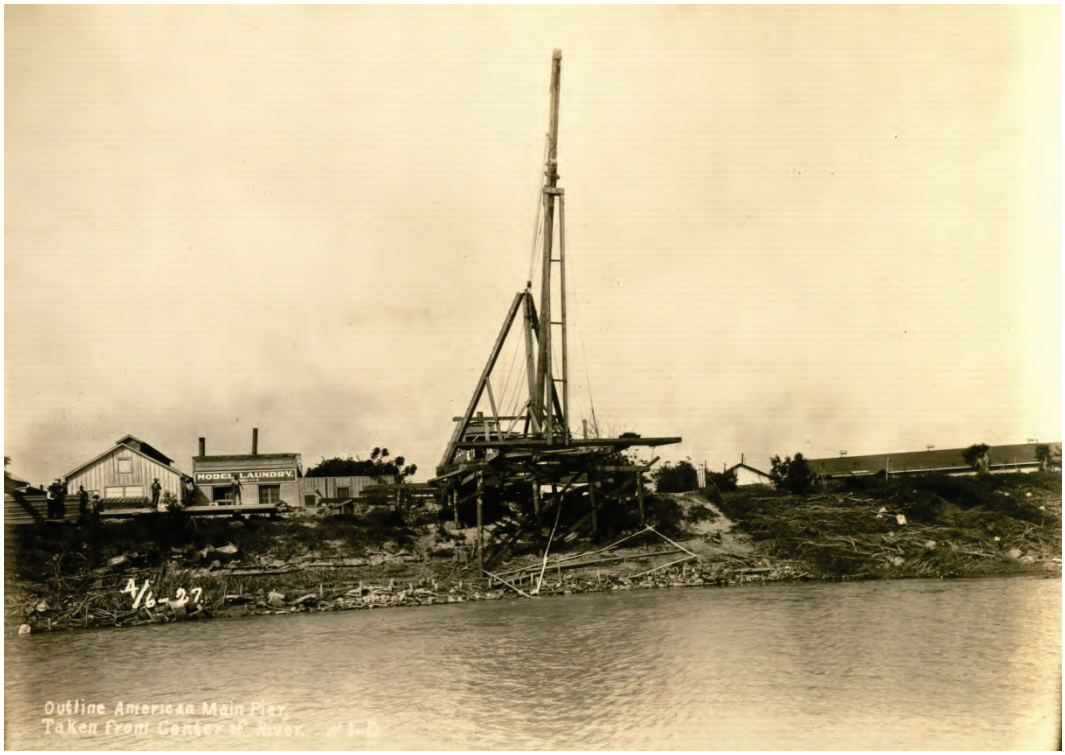
Figure 3.8 shows a close-up view of the timber works for the bridge pier construction and riverbank conditions during this time, which corresponds to the area incorporating the study reach. Visible in this photograph is the presence of large stone riprap along the river edge, driftwood, and other debris deposited by a drop in river level. The light-colored riprap shown in this photograph is possibly crystalline limestone, which was encountered in

borings at 10- to 15-ft-depth drilled for this study in 2014 (described in next section). The riprap is not native to this area and was likely obtained from sources outside of the LRGV to protect the bank from active migration. The bank has a relatively moderate slope to the river and shows a much reduced levee prism than currently present, which was under city/county jurisdiction prior to being federalized by the USIBWC in the 1930s.

Figure 3.8. View of the riverbank in 1927 during initial construction of the pier for the Gateway International Bridge. Study area is right of the bridge pier construction.

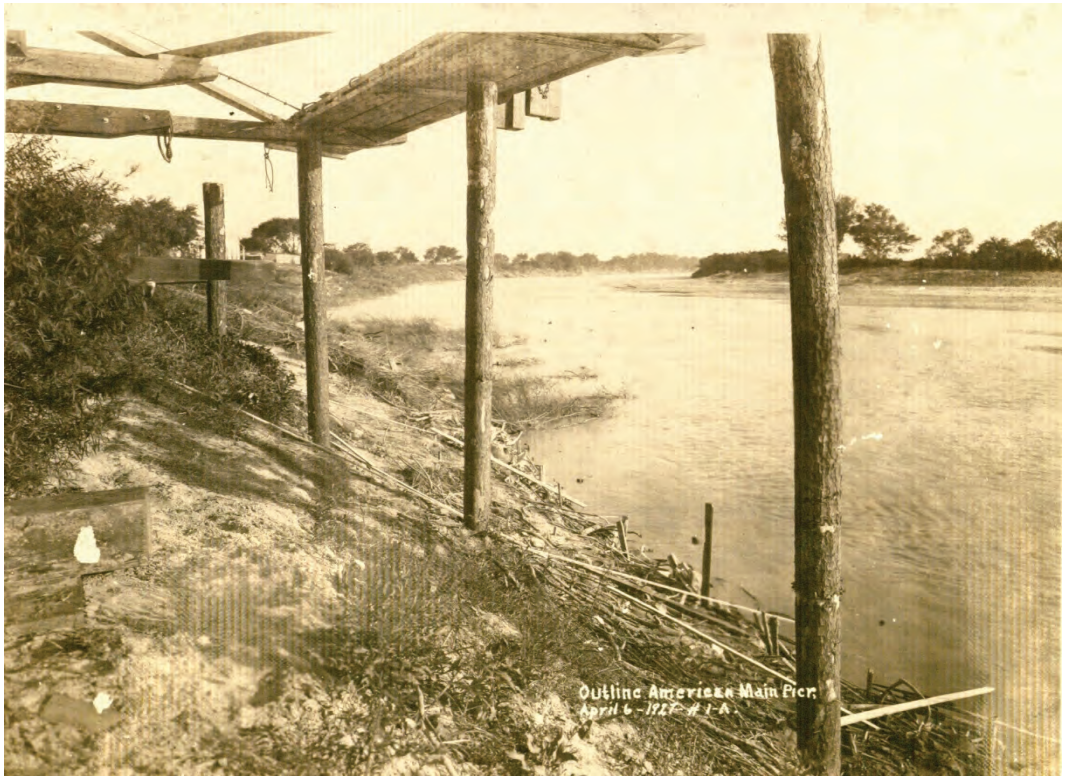
Figure 3.9 is photographed from beneath the pier with a view looking downstream that shows riverbank conditions along the entire study reach. As this photograph clearly shows, the river channel and bank are significantly different than conditions that currently exist today. The channel is much wider, with a moderate side slope that is approximately 1V to 3 H. The bridge was completed by 1928. The USGS topographic map from 1930 (Figure 3.4) identifies the bridge alignment and is consistent with the early photographs showing construction details.

Figure 3.9. View of the study area riverbank in 1927 from beneath the frame support for the Gateway International Bridge pier. View is looking downstream and shows a bank slope of approximately 3H:1V.

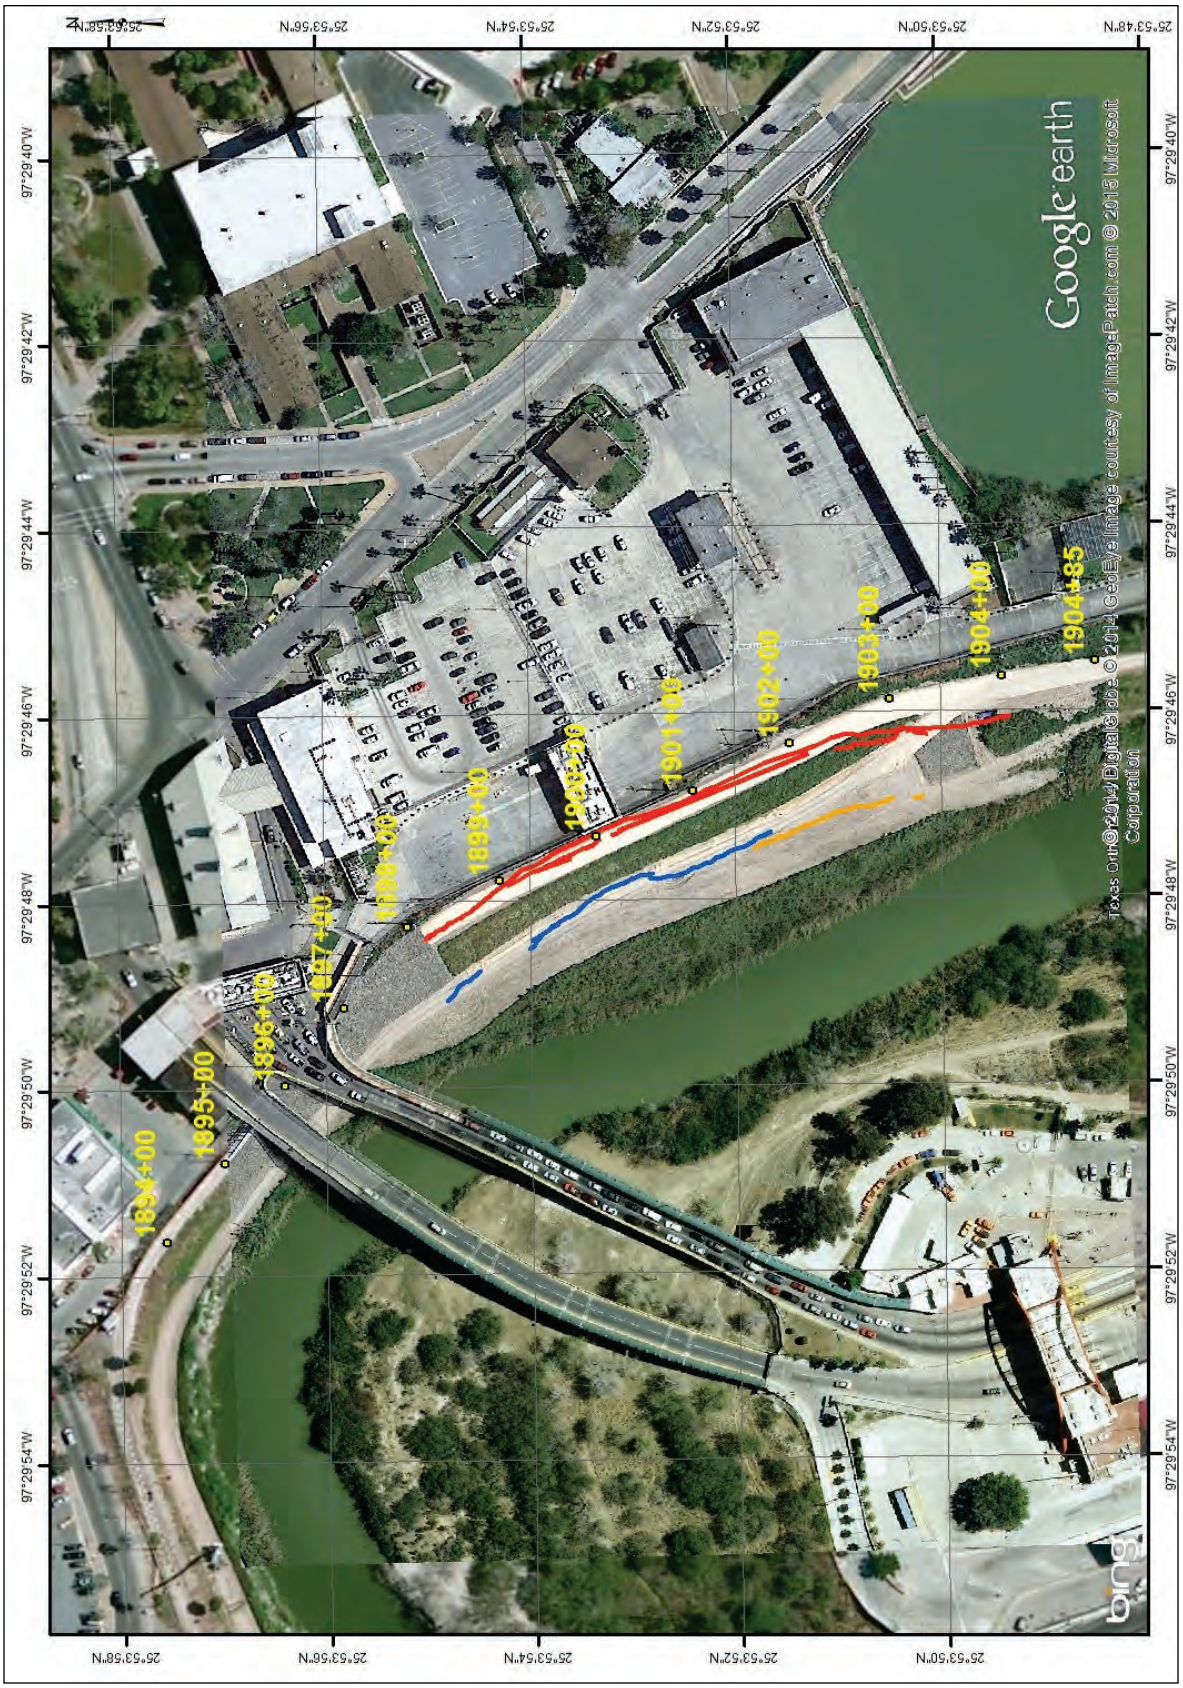
Figure 4.1. Location of major crack sets in the study reach denoted by color and levee stationing in yellow (merged Bing and Google images).

Three longitudinal crack sets, extending between levee stations 1898+00 to 1904+00, had developed as shown by Figure 4.1 (see also Figures 1.2 to 1.4). These crack sets were grouped based on their positions and by the displacement exhibited. Cracking may likely extend beneath the riprap that was used to armor the slope beneath and downstream of the Gateway International Bridge. However, rock was not removed between stations 1897+00 to 1898+00 to verify the crack limits under the riprap section. Pin flags with colors designated in Figure 4.1 were used to highlight and mark the major crack sets as shown by Figure 4.2 to 4.4.GPS mapping with a Trimble model GeoXH was subsequently performed to accurately locate the cracks. Results of this mapping effort are shown on the aerial image of the study site in Figure 4.1 using GIS technology.

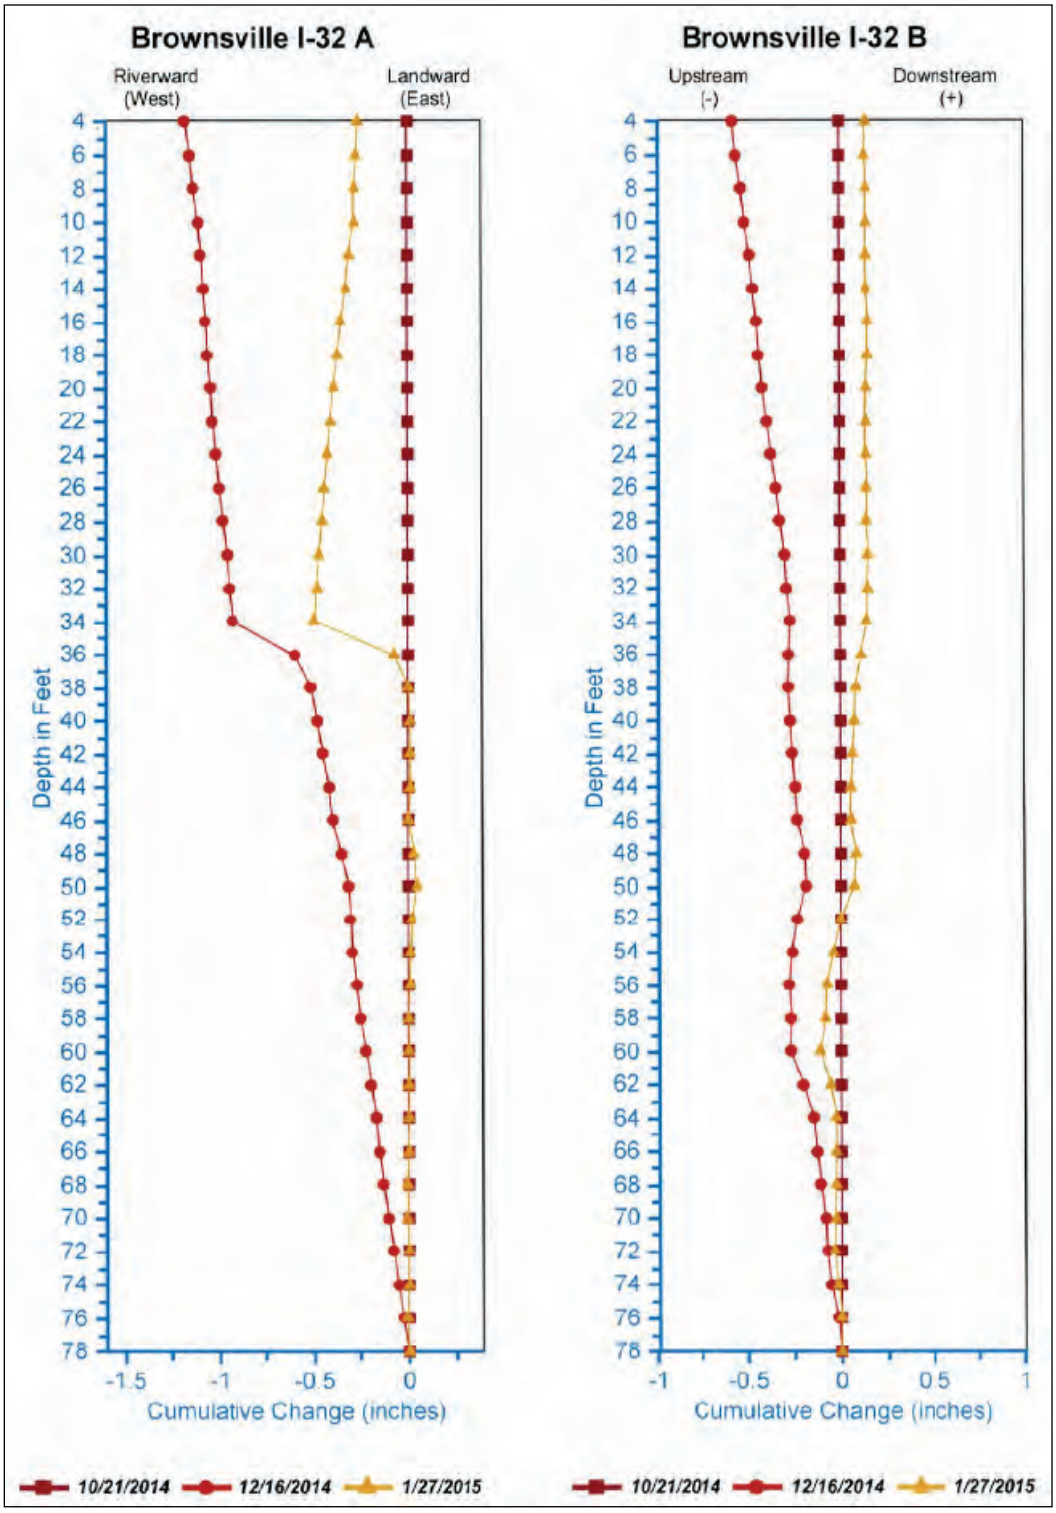
Figure 4.9. Inclinometer data as of 27 Jan 2015 for I32.

riverbank in I34 (Figure 4.11). Maximum total displacement of the bank at all three inclinometers is approximately 1 in. riverward since the first measurement was taken on 15 October 2014.

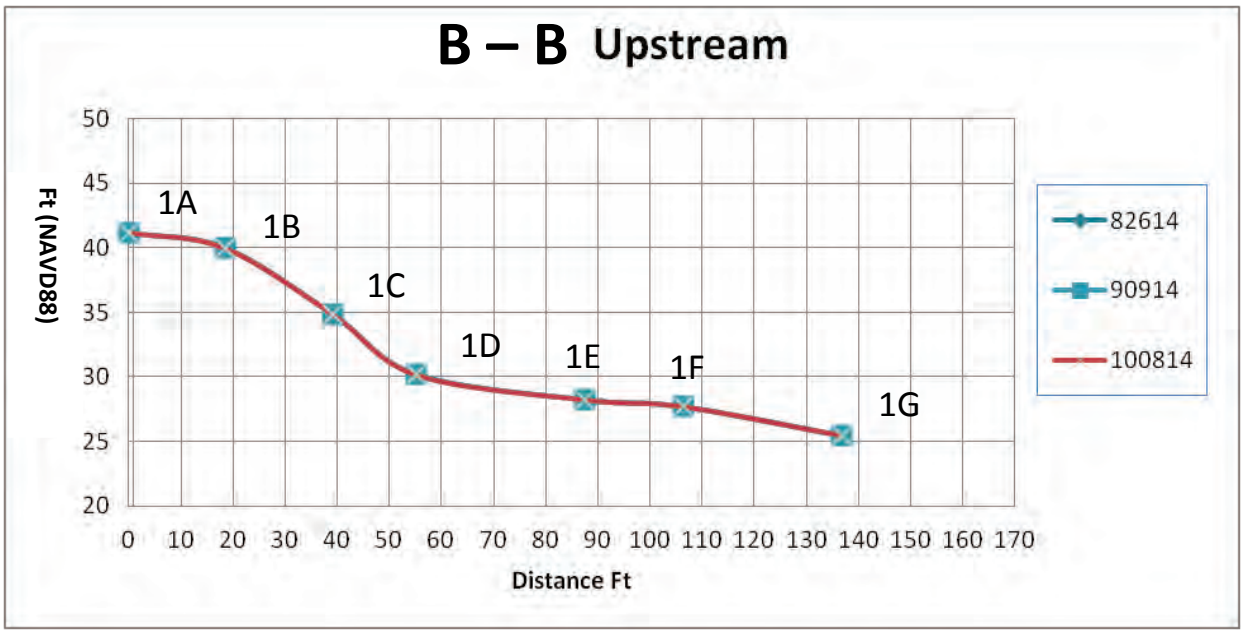
Figure 4.13. Total station survey profile for upstream levee section (location corresponds to geologic cross section B-B') showing levee and bank geometry, and the absence of appreciable movement between survey periods 26 Aug to 8 Oct 2014 (see Table 4.2).

Comparison of point measurements along each of the three survey transects is presented in Figures 4.13 to 4.15 and Tables 4.2, 4.3, and 4.4 for the upstream, center, and downstream profiles, respectfully. These profiles correspond to locations where geologic cross sections were constructed from the boring and CPT data (i.e., sections B-B′, C-C′, and D-D′, respectively). Values shown in the referenced tables correspond to the cumulative differences measured for each point in the x (easting), y (northing), and z (elevation) components for surveys made on 26 August and 8 October 2014. Negative (decreased) and positive (increased) values indicate the direction of the cumulative movement that was measured for the two surveys. Values measured were in the hundredths to thousandths of a foot range as shown by Tables 4.2 to 4.4 (points A at crest and G and H are at riverbank). This measured range of movement was considered relatively insignificant in terms of the cumulative displacement that was observed by visual inspection. It was concluded that the major period of surface deformation occurred before the monitoring network was established. The range of movements measurements indicated that a longer period of time between surveys was warranted.

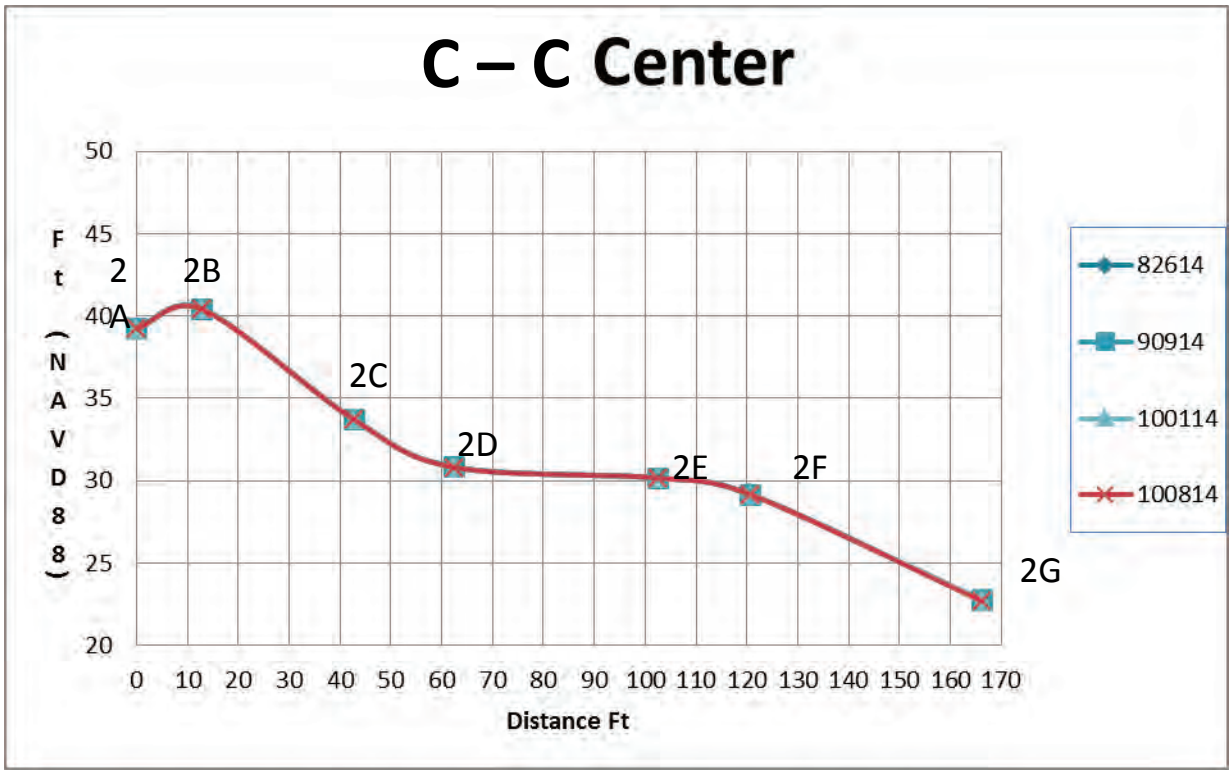
Figure 4.15. Total station survey profile for downstream levee section (location roughly corresponds to geologic cross section D-D') showing levee and bank geometry, and the absence of appreciable movements between survey periods 26 Aug to 8 Oct 2014 (see Table 4.4).

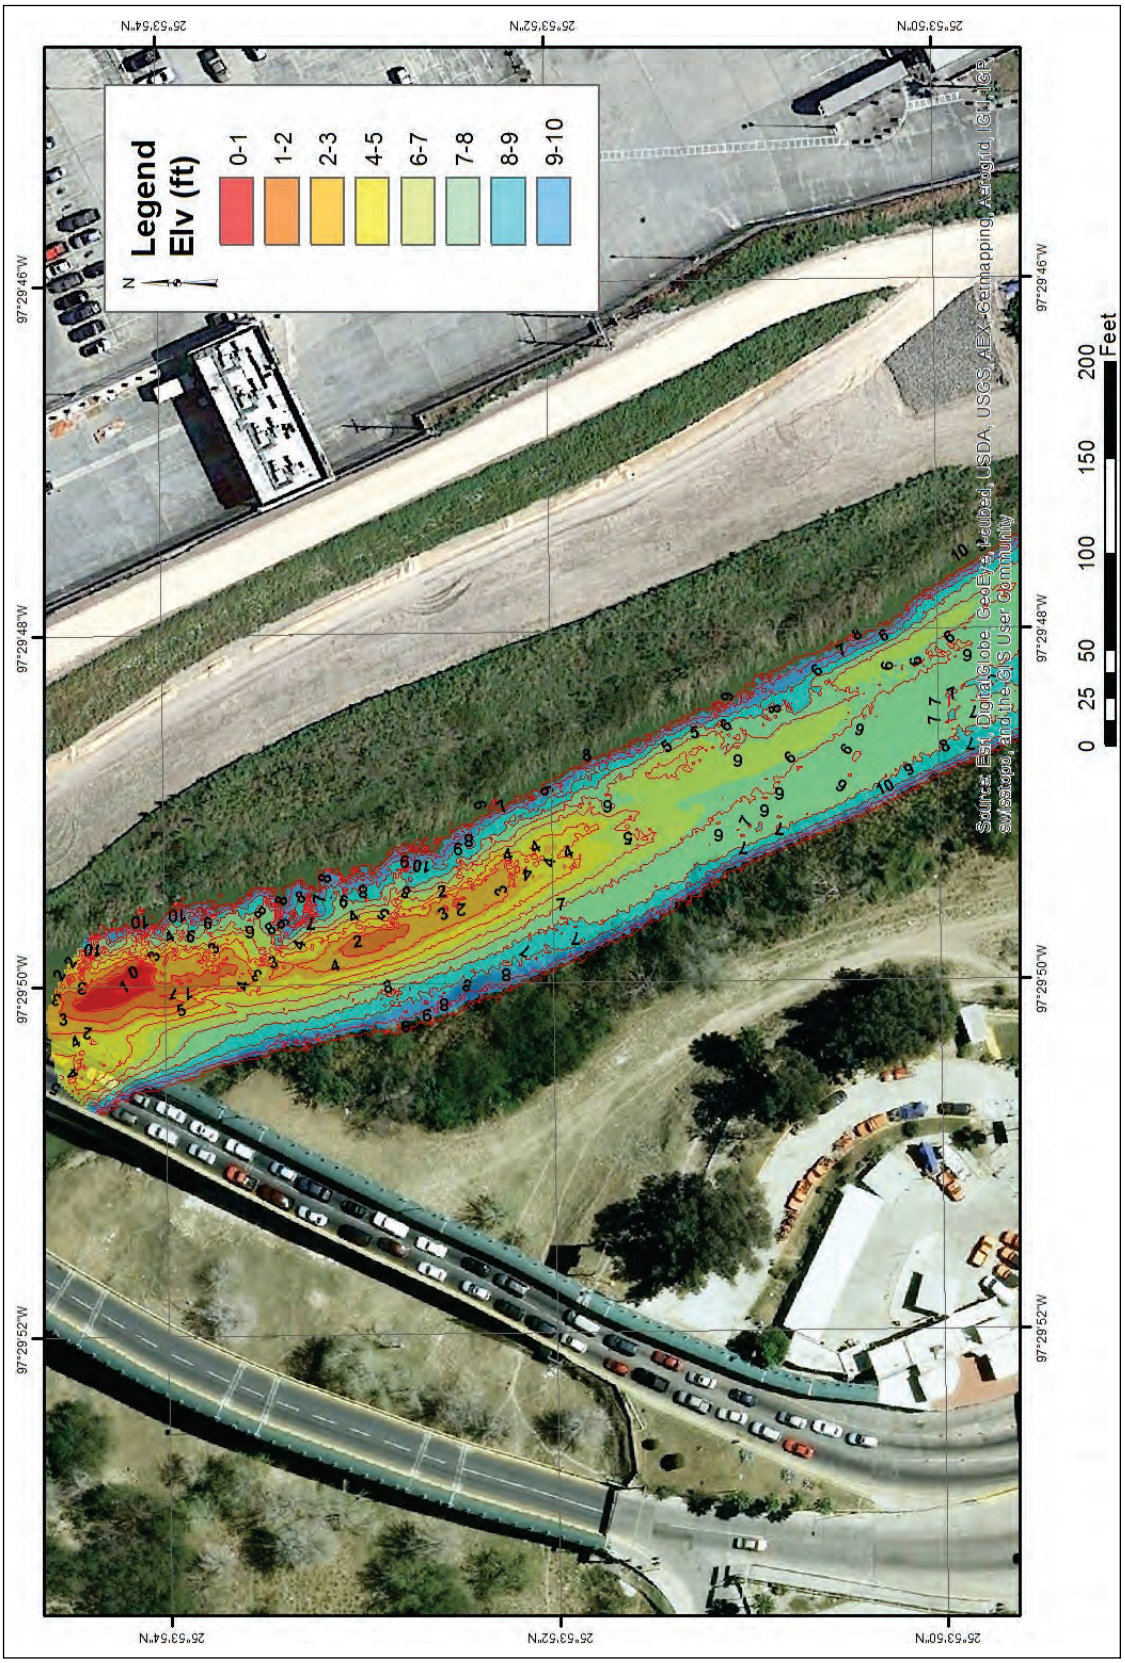
Figure 4.16 presents the bathymetry data collected from the study area taken 10 to 12 September 2014. Elevation data from this survey were used to identify a deep scour hole present in the bendway, extending downstream of the bridge and with an elevation of less than 1 ft NGVD. The thalweg (deepest point in the river) then crosses toward the Mexico side of the river, where the channel bottom elevation begins to rise to between 2 and 4 ft NGVD. Further downstream, the elevation is between 6 and 7 ft NGVD. Also noticeable in this figure is the hummocky topography of the U.S. channel bank, which displays a scallop outline and indicates a history of past bank slumping activity. Bank slumping was noted by ERDC personnel during field visits to the site in 2014 (Figure 4.17).

Figure 4.16. Bathymetry data showing elevation of the channel bottom. Bathymetry data were collected on 10 to 12 September 2014. Note the jagged U.S. bank line and scalloped topography below the water surface.

Figure 4.17. Active bank slumping occurring along riverbank adjacent to person in photograph. Photograph is in the middle of the study reach. Photograph was taken in July 2014 after the brush was cleared from the bank to permit close inspection.

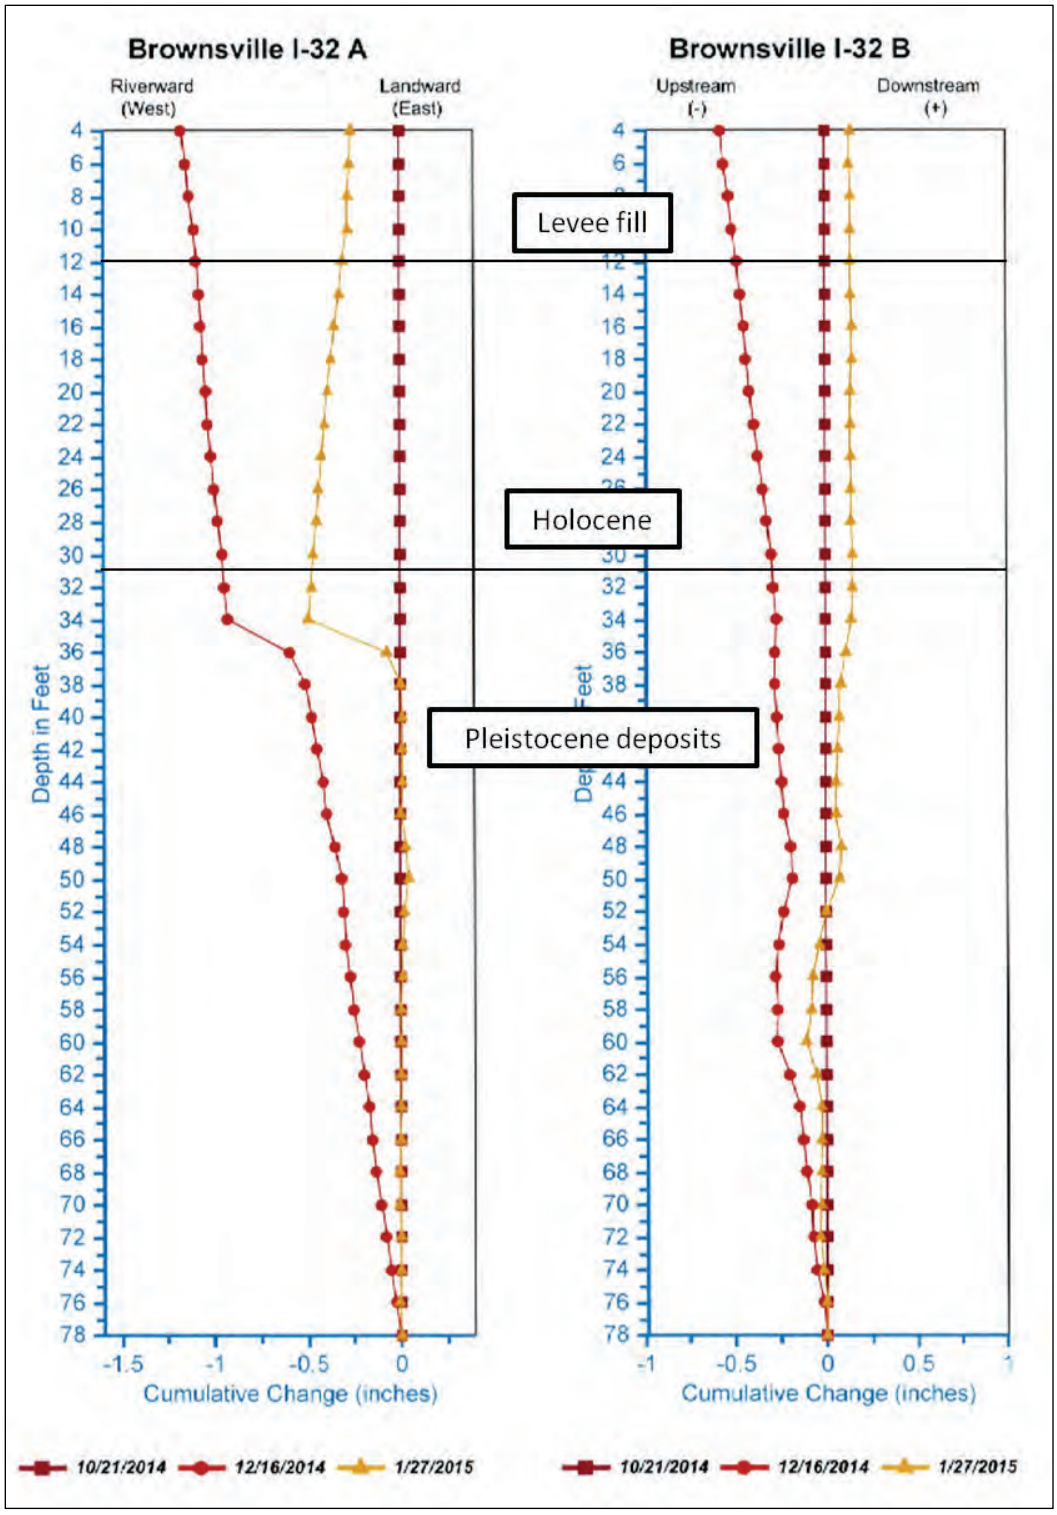
What is surprising is the interval where deflection begins to occur in relationship to the basic stratigraphy. At the levee crest, 32I deflection starts in the Upper Pleistocene stratigraphy between 34 and 36 ft. At the levee toe, 33I deflection occurs at the contact between the historic fill and the Pleistocene surface. Near the river at 34I, the deflection interval starts below the Pleistocene contact between 32 and 36 ft.

Figure 5.16. Inclinometer data with basic stratigraphy as of 27 Jan 2015 for I33.

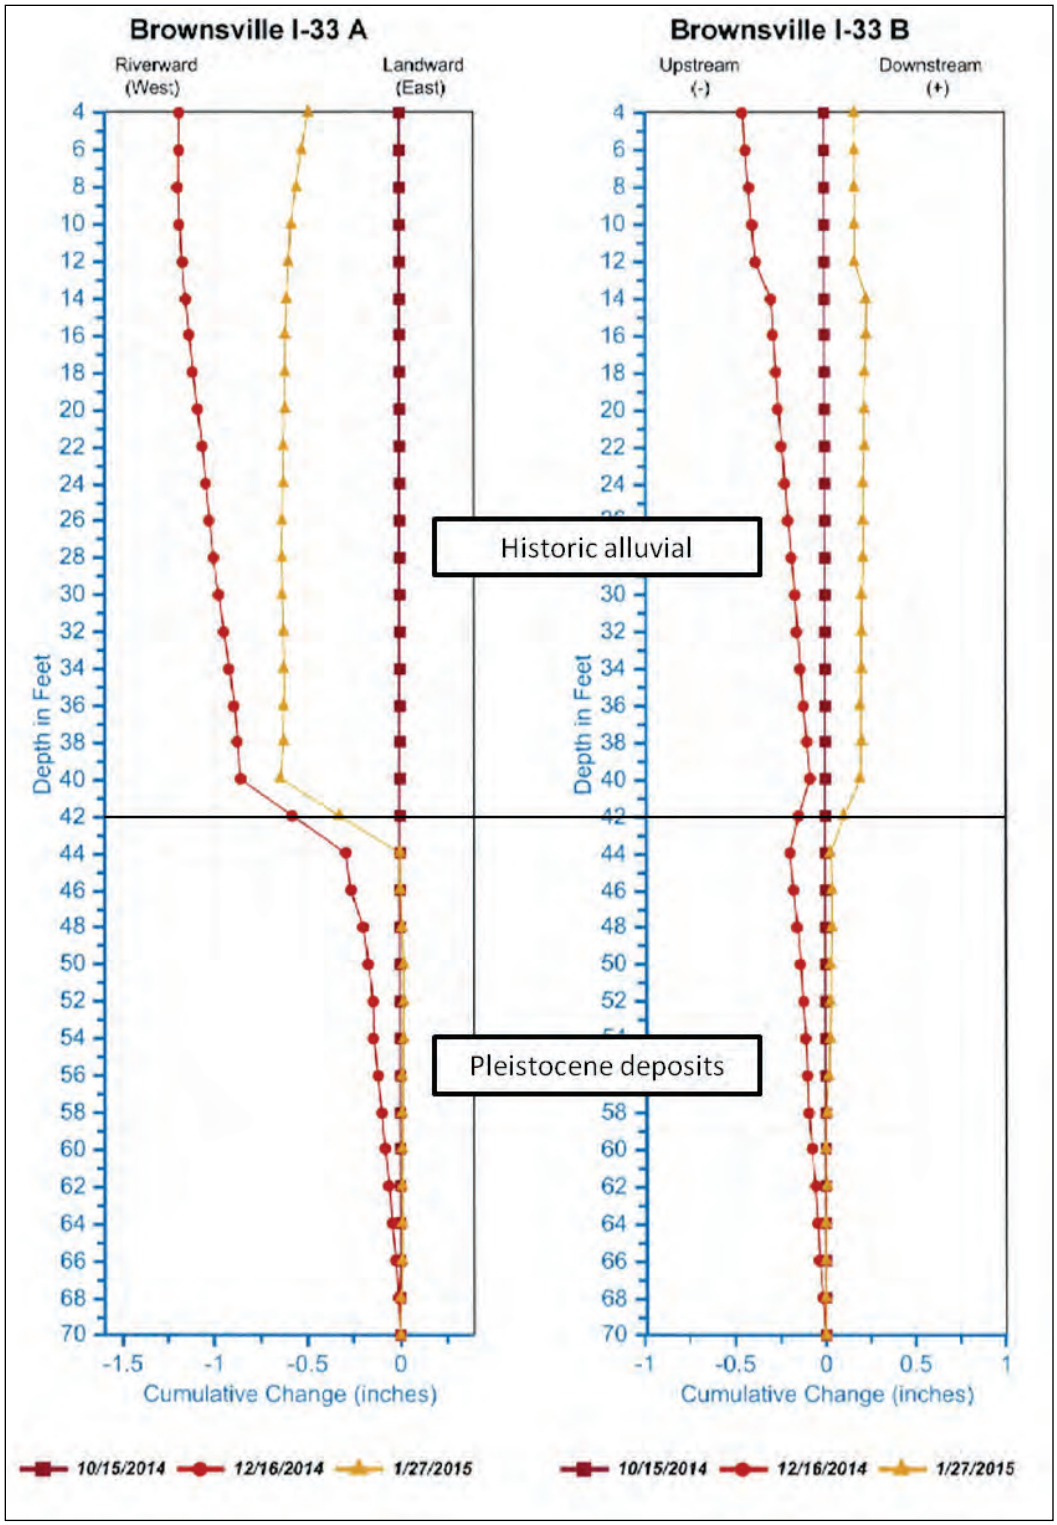
Figure 5.17. Inclinometer data with basic stratigraphy as of 27 Jan 2015 for I34.

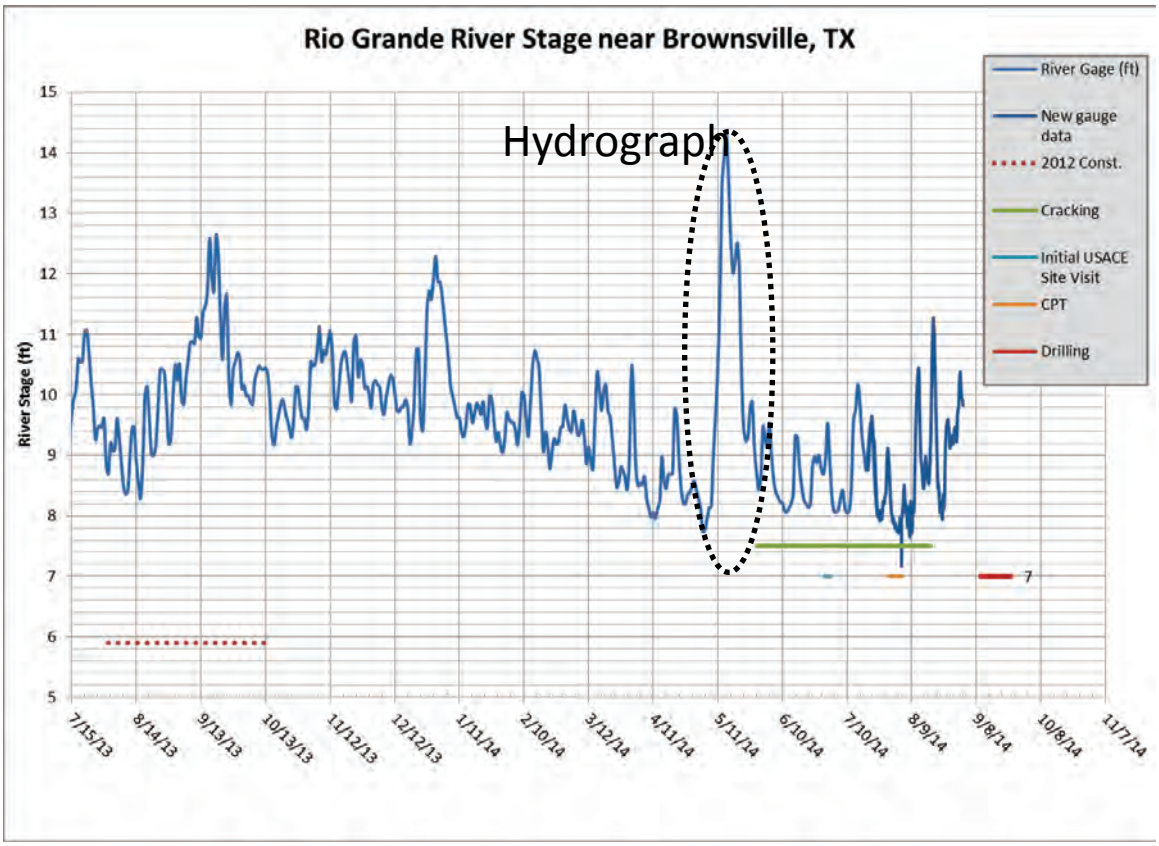
Both seepage and stability analyses were conducted to better understand the partial levee failure from the rapid fall and rise in river stage that began in April 2014. The hydrograph shown in Figure 6.1 displays a peak value of 14.31 ft in the middle of May 2014. The top of bank elevation is approximately 25 ft and the levee toe at an elevation of 30 ft, as shown in Figure 5.7. The hydrograph indicates that the incident that may have initiated the levee instability was a relatively minor fluctuation of river stage. If this drawdown in river stage triggered the movement of the levee as a series of creep events, the factor of safety against this type of failure mode was very low.

Figure 6.1. River stage and post instability sequence of events.

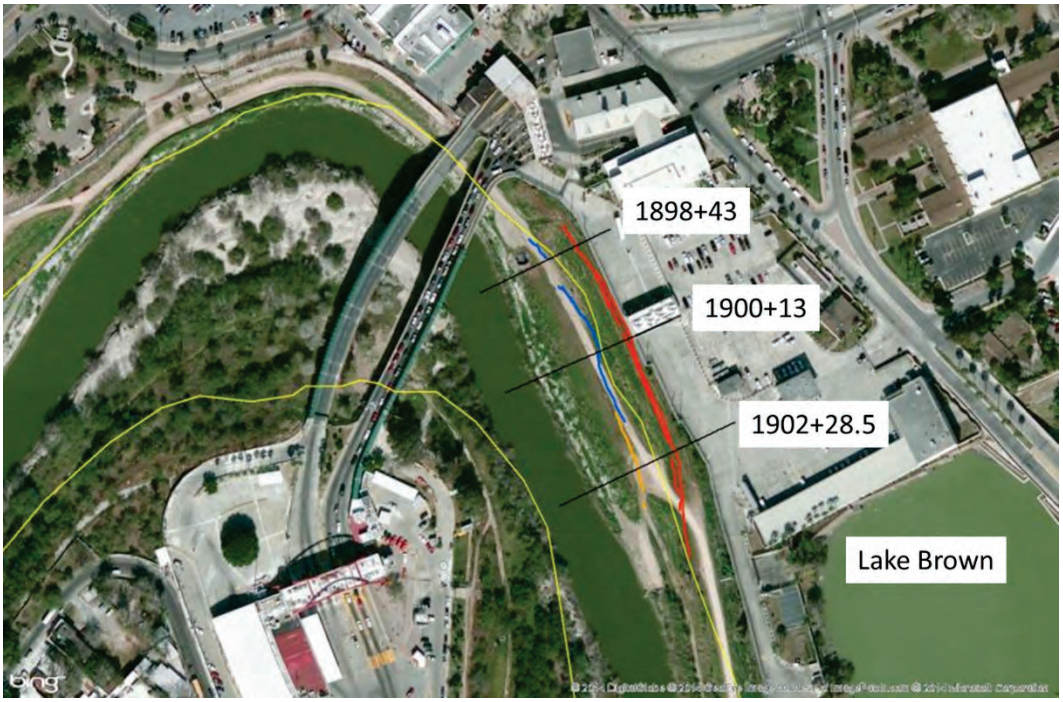
Review of historic maps showing the previous courses of the Rio Grande indicates that the area on the waterside of the levee between the toe and river channel contains younger alluvial fill as compared to that on the landside of the levee. Yellow lines in Figure 6.2 show the location of the 1930 river channel, and the blue, red, and orange lines represent the locations of the levee cracking that occurred in 2014. The presence of the younger alluvial fill on the waterside of the levee indicates that there may be weak zones in the area providing support to the levee.

Figure 6.2. Section and cracking locations; see Figure 3.10 for old channel limits (yellow line).

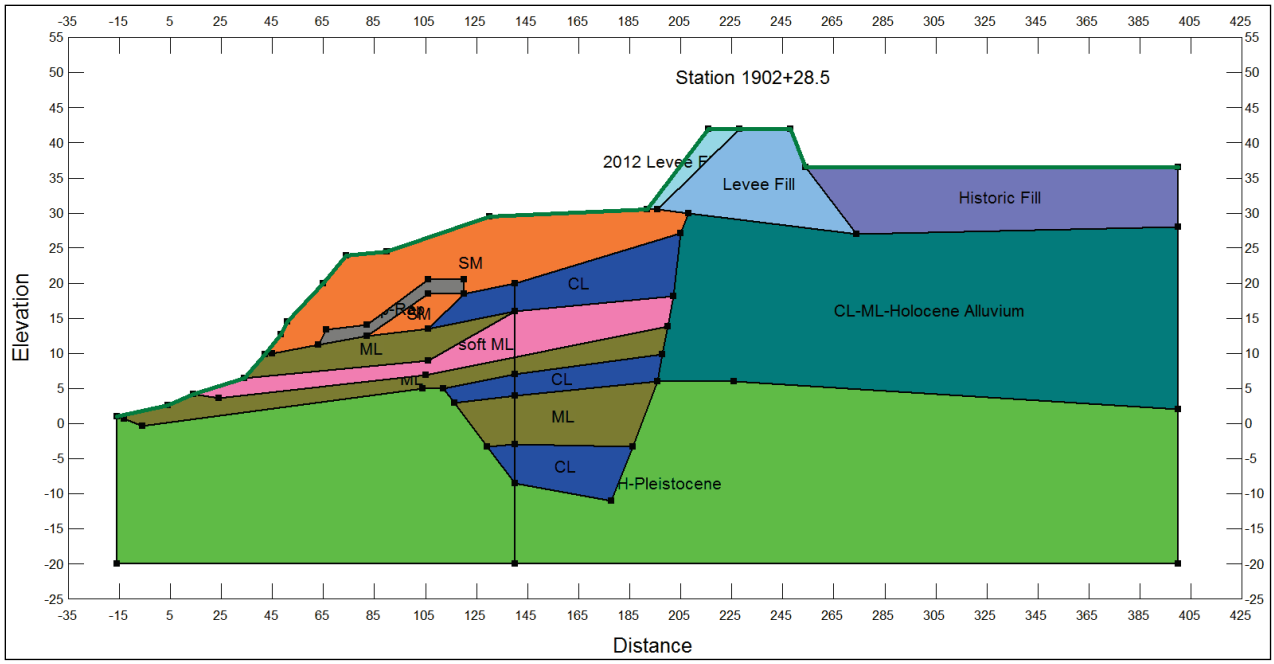
Figure 6.6. Cross section at station 1902+28.5.

Figure 6.6 shows the section analyzed at station 1902+28.5, the farthest section downstream. This section is different when compared to the other two sections; the weak zone is lower in elevation, and there is a zone of riprap and a low plasticity clay layer (CL). The elevation of the top to the riverbank is 22.54 ft, and the slope of the bank is approximately 1.95H:1.0V.

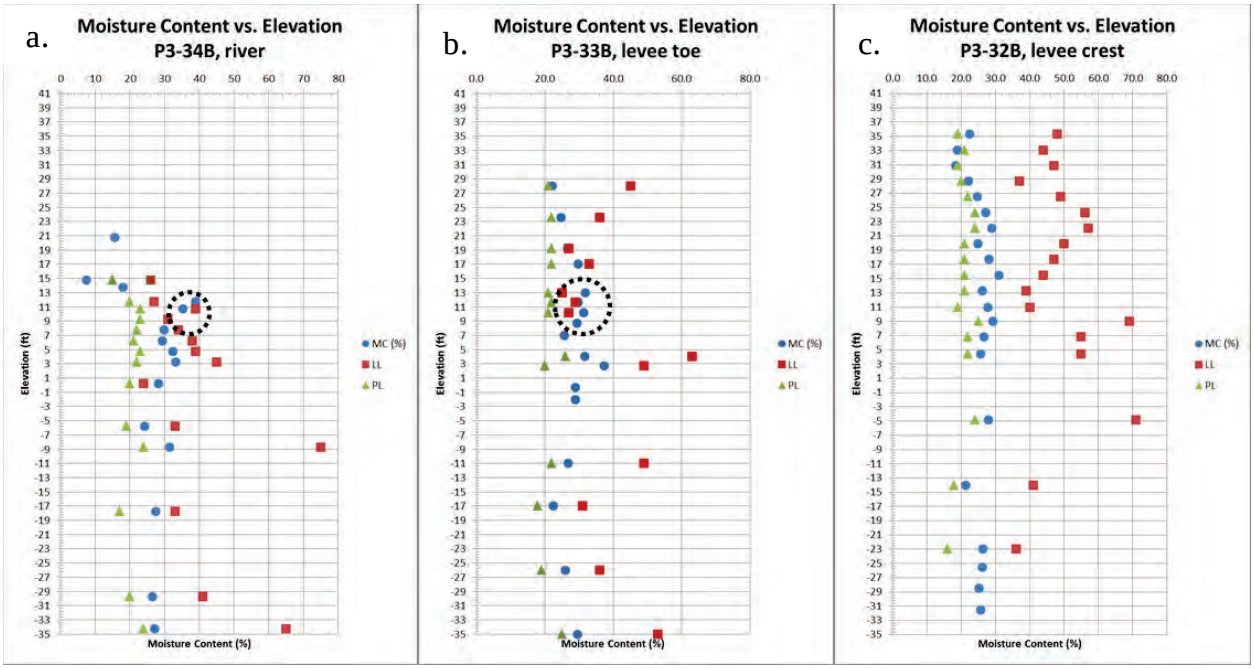
Figure 6.7. Moisture content profiles at station 1900+13.

Profiles a and b, shown in Figure 6.7, exhibit smaller plasticity indices when compared to profile c, indicating that there is a material difference. This difference supports a change between the Holocene alluvium and the younger alluvial materials in the soil cross section.

The natural moisture content is larger than the liquid limit between elevation 9 ft and 13 ft in both profiles a and b, indicating a zone of lower shear strength. This lower shear strength could be due to a failure surface passing through this zone. Another possibility is that the material could have mobilized and softened due to displacements that occurred during the levee instability.

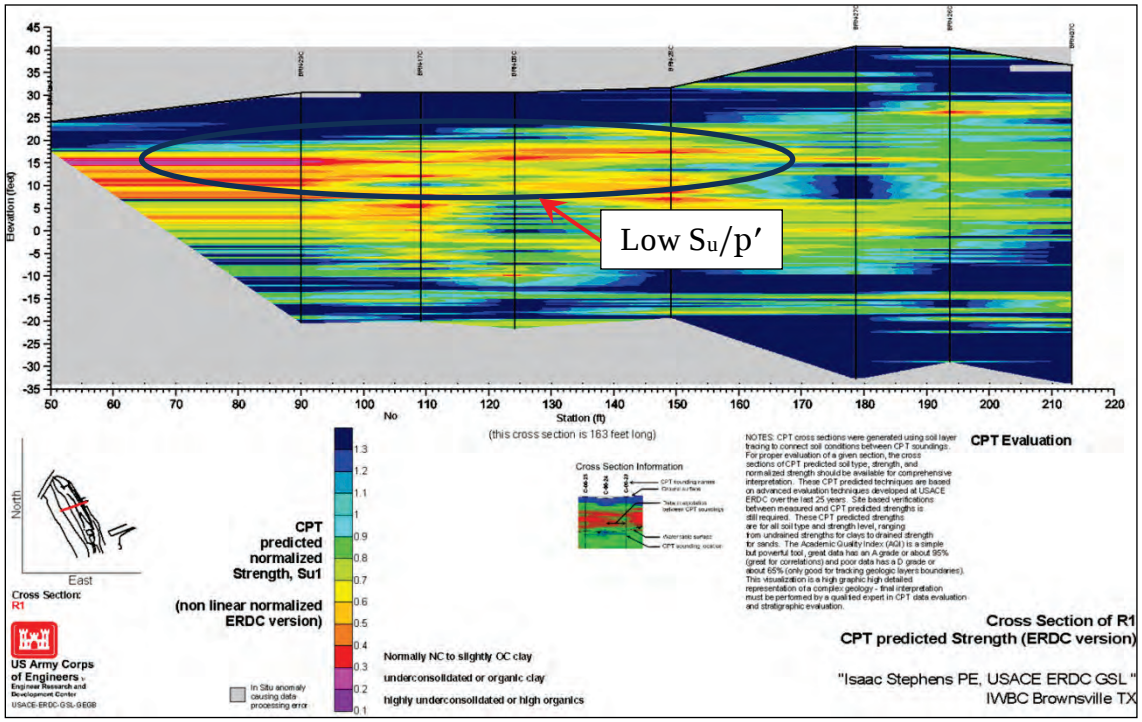
A CPT cross section showing undrained strength (S_u) normalized with effective confining pressure (p′) is shown in Figure 6.8. From elevation 10 ft to 17 ft, extremely low S_u/p' values were identified ranging from 0.2 to 0.4 that start near the levee toe and extend toward the river (see Figure 6.8).

Figure 6.8. CPT predicted undrained shear strength at station 1900+13.

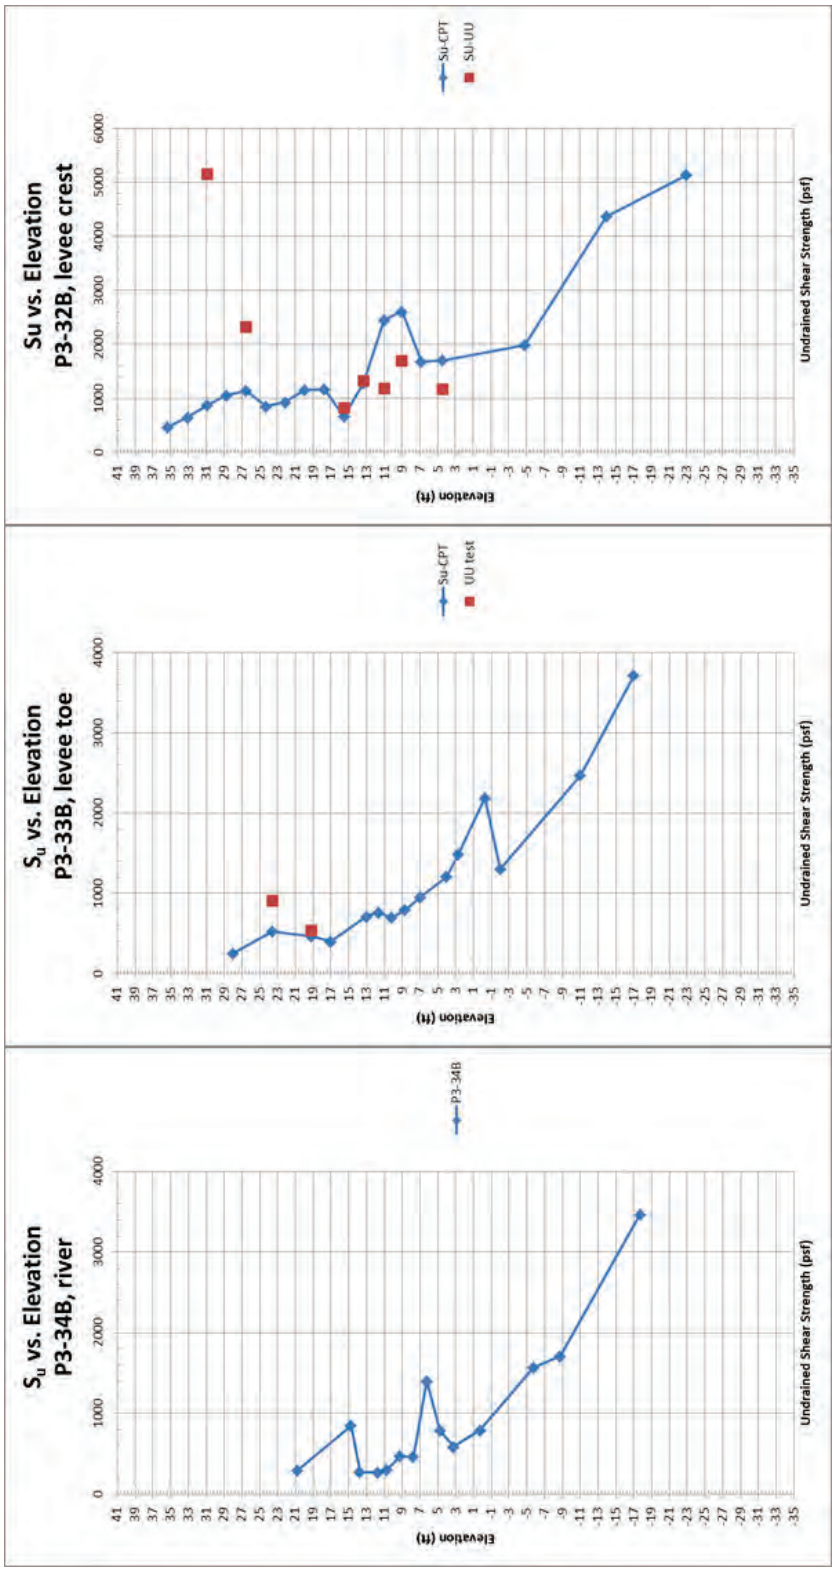
Figure 6.9 shows the undrained strength profiles for the three borings used in the moisture content profiles (Figure 6.7). The undrained strength profiles shown in blue were derived from the CPT correlations, and the red squares represent the results of the UU triaxial testing. Relatively good agreement can be seen between the two tests especially near the zone where the high LL and low S_u/p' values were found. In areas above and below the weak zone, the CPT values under and over predict the value of the undrained shear strength compared to the results of the UU tests.

Figure 6.9. Undrained shear strength profiles, CPT and UU test.

Standard penetration tests (SPT) conducted during soil boring resulted in blow counts of less than five in this zone of higher water contents and in some places was less than one, meaning that the SPT fell under its own weight. A sensitivity analysis was conducted by varying the undrained shear strengths for the soft material shown in Figure 6.4. The range of undrained shear strengths used in the sensitivity analysis ranged from 140 to 225 psf. At the other two sections, the soft zone were assigned an undrained shear strength value that correlated to the value found from the CPT and were 260 psf at station 1902+28.5 and 200 psf at station 1898+43.
